BELZONA PROVIDES FAST INTERIOR PROTECTION OF TWO CYANIDE DESTRUCTION TANKS

ID: 5092

Industry: *Mining & Quarrying*
Application: *TCC-Tanks and Chemical Containment Areas*
Substrate: *Steel ASTM A36*
Products: ** Belzona 4151 (Magma-Quartz Resins) ,*

Customer Location: *Gold mine*
Application Date: *September 2009*

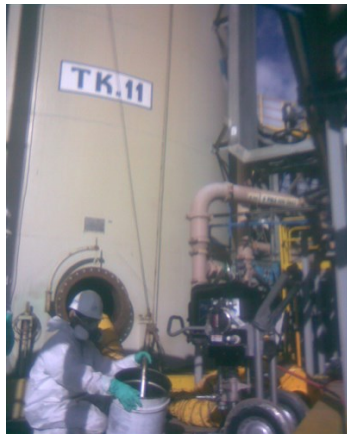
Aggressive chemical attack, cavitation and erosion of suspended solids in processing tanks that operate with permanent entry and exit of fluids and mixing blades.

- * Original conditions in the interior of the tank ,
- * Image of the tank and airless spray equipment ,
- * Mixing Belzona 4151 ,
- * Application completed ,

After blasting, Belzona 4151 was applied with airless spray equipment in accordance with Belzona Know-How System Leaflet TCC-5.
