Belzona® 4181 Repairs and Protects Water Treatment Plant Floors

Customer Location: Power Authority, San Antonio, Texas USA

Application Date: January 2004

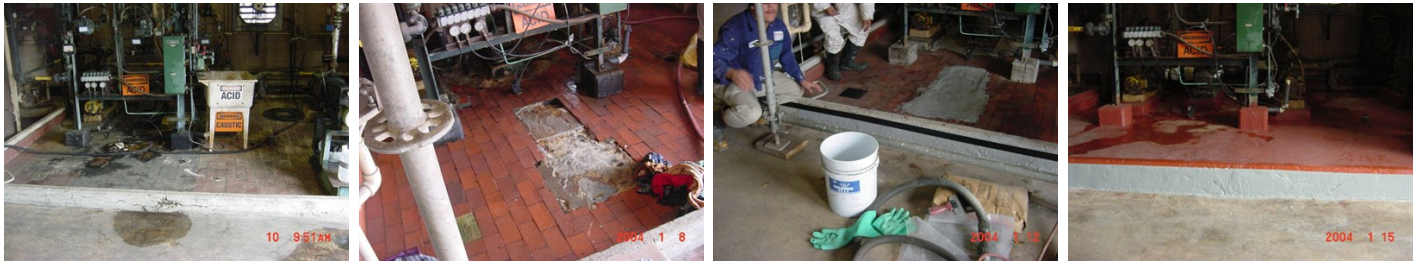
Photograph Descriptions

Acid and Caustic spills were eating into the rough brick floor. Environmental and safety concerns became critical.

- * Demineralization chemical handling area ,
- * Area following surface preparation and cleaning ,
- * Belzona® 4111 was used to patch holes in floor and curb area where appropriate ,
- * Finished project ,

Application was carried out in accordance with Belzona Know-How System Leaflets FPA-1 & FPA-3.

Client needed a solution to a containment problem. Area to be protected was uneven and rough. The mortar-like consistency of Belzona® 4181 made it ideal for this repair.
