Belzona® 1321 Injects New life into Old Shaft

ID: 511

Industry: *General Industry*
Application: *MPT-Mechanical Power Transmission*

3" diameter shaft on the canning line of a local brewery

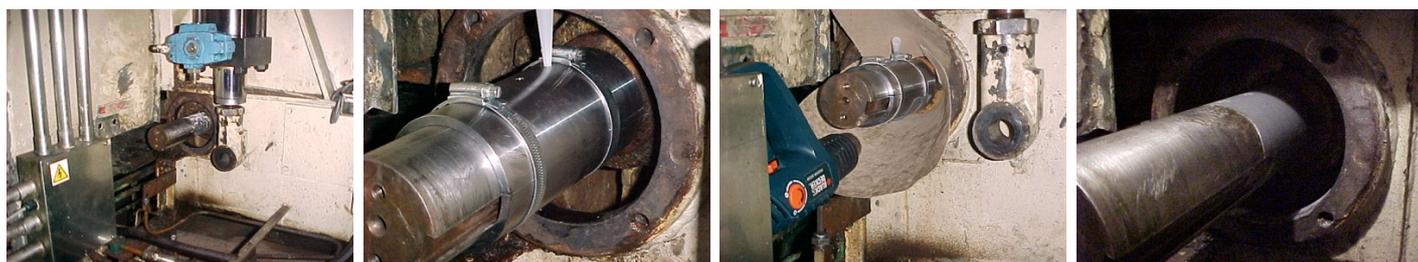
Photograph Descriptions

A collapsed bearing had caused excessive wear to the shaft necessitating either a full repair or replacement.

- * The shaft location showing restricted access ,
- * The former in place with nozzle for venting ,
- * Post curing the repair to reduce downtime ,
- * The finished shaft ,

Application carried out in accordance with Belzona Know-How System Leaflet MPT-2.

Replacement of the shaft was considered the only alternative - the problem being it was costly and time consuming, around £20,000 (\$40,000) for a new shaft and five days of downtime. The Belzona solution was carried out in under one shift period thanks to the ability of Belzona to be post-cured and is still working today.
