BELZONA REPAIRS STEAM TRAIN FOR UNDERGROUND ANNIVERSARY

Customer Location: Locomotive repair workshop, Forest of Dean, UK

Application: ENC-Engines and Casings

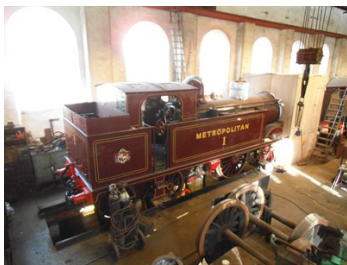
- * Metropolitan number one shown with a heated application hut built around the front nose section ,
- * Steam chest after grit blasting and application of Belzona 1511 under doubler plates bolted into place ,
- * Belzona 1391 applied over the doubler plates ,
- * Belzona 4181 applied as a final protection from foot traffic ,

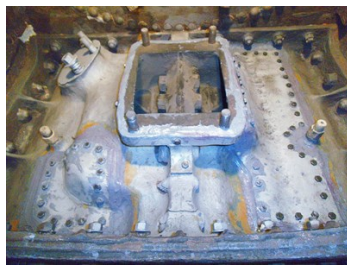
The steam chest (part of the main cylinder block on the train engine) had corroded and had several holes due to steam pressure and the corrosive chemicals wearing it away over many years. Without fixing these holes the engine would lose pressure and fail to run.

Application was carried out in accordance with Belzona Know-How System Leaflets ENC-1 and modified FPA-1. Doubler plates were

bonded in place with Belzona 1511 before being coated with Belzona 1391 to provide corrosion protection. Belzona 4181 was then applied to give additional corrosion resistance and resistance to foot traffic during maintenance work. The repair was then overlaid with fire clay to give an authentic appearance.
