Keeping the rain out with Belzona Expansion Joints

ID: 512

Customer Location: *Local Authority, St.Helens, UK*

Application Date: *June 2004*

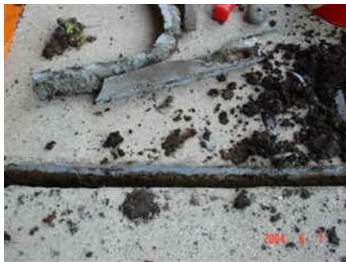
- * Old joint being scraped out ,
- * Joints masked off ready for re-filling ,
- * The completed repair ,
- * An external 7-meter vertical expansion joint ,

The old expansion joints were not flexible enough and were allowing rainwater to seep through into the neighboring dwellings causing damp problems. The joints were removed and filled using Belzona® 4521 for the horizontal joints and Belzona® 2211 for the vertical. A layer of Belzona® 2211 was also applied over the horizontal joints to improve the aesthetics of the repair.
