# Keeping the rain out with Belzona Expansion Joints

**Industry:** Buildings & Structures  
**Application:** FPA-Floor Problem Areas  
**Substrate:** Asphalt and brick  
**Products:** \* Belzona® 4521 (Magma-Flex Fluid) ,  
\* Belzona® 2211 (MP Hi-Build) ,  
\* Belzona® 4111 (Magma-Quartz) ,

**Customer Location:** Local Authority, St.Helens, UK  
**Application Date:** June 2004

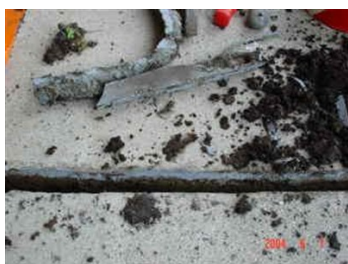
- \* Old joint being scraped out ,
- \* Joints masked off ready for re-filling ,
- \* The completed repair ,
- \* An external 7-meter vertical expansion joint ,

The old expansion joints were not flexible enough and were allowing rainwater to seep through into the neighboring dwellings causing damp problems. The joints were removed and filled using Belzona® 4521 for the horizontal joints and Belzona® 2211 for the vertical. A layer of Belzona® 2211 was also applied over the horizontal joints to improve the aesthetics of the repair.
