CONDENSER REPAIRED WITH BELZONA

Customer Location: *Metallurgy Complex, Thermal Power Station, Vologda region, Russia*

Application: *HEX-Heat Exchangers*

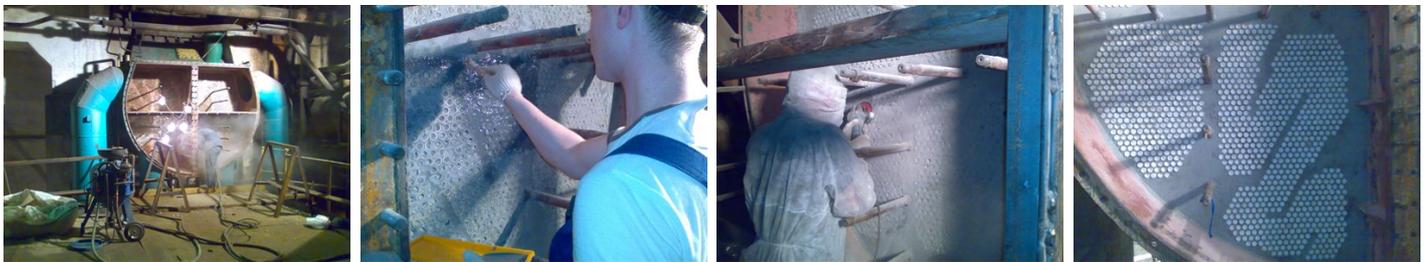
Photograph Descriptions

Machine was in service for a long time, which resulted in unacceptable tube sheet wear (thinning, in some places up to 5-7 mm from the original thickness of 40 mm)

- * Grit blasting of the metal ,
- * Corks placed in the holes, application of Belzona 1311 ,
- * Machining of the finished application ,
- * Application of Belzona 1321 ,

Deformation of the tube sheets due to bimetallic corrosion and erosion

The application was carried out in accordance to Belzona Know-How System Leaflet HEX-1. The repair was completed in 10 days by a team of 4 specialists
