# BELZONA repairs and protects a heat exchanger against erosion/corrosion

ID: 5160

Customer Location: Oil refinery "Ukratnafta" in  
Kremenchug city, Ukraine

Application: HEX-Heat Exchangers

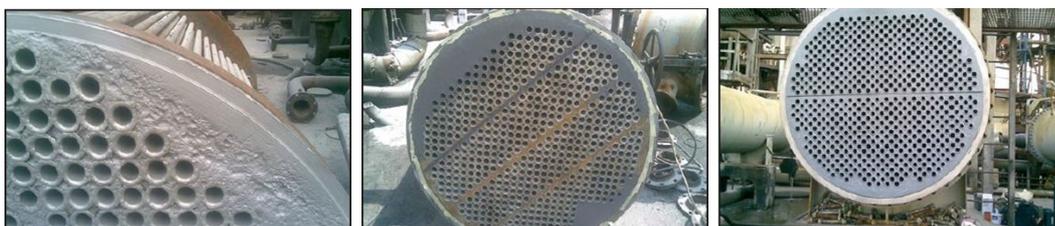
Problems due to high temperatures and erosion caused by particle flow

- \* Erosion/corrosion of the heat exchanger ,
- \* Geometry repaired using Belzona 1311 ,
- \* Repaired surfaces of the heat exchanger after the application of Belzona 1311 and Belzona 1391 ,

Erosion/corrosion on surfaces of the heat exchanger

The application was carried out according to Belzona Know-How System Leaflet HEX-1 and HEX-3

Tube sheet surface has been restored and coated with Belzona within two days. Belzona application allowed to protect the heat exchanger from future erosion and corrosion, thus avoiding replacement.
