# BELZONA REPAIRS THIN WALL DEFECT IN COOLING WATER SYSTEM

Customer Location: Nutritional products manufacturer,  
Dalry, Scotland

Thin wall defect on cooling water pipework

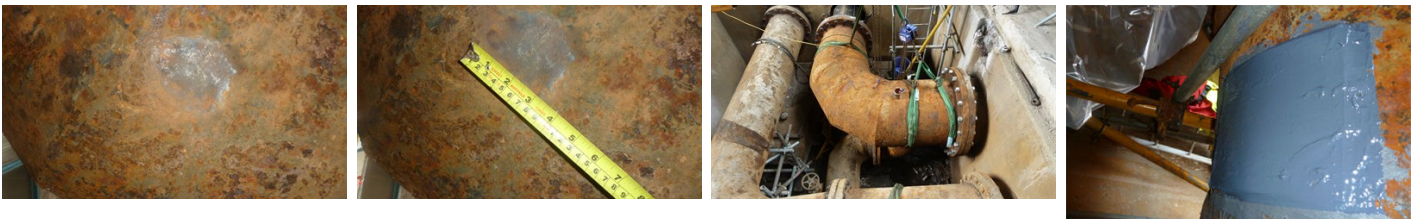
## Photograph Descriptions

General corrosion had reduced original 10mm pipe wall thickness to 5-6mm but excessive grinding of the substrate during preparation for non destructive testing created a local defect with wall thickness of 2mm.

- \* Local defect on the cooling water pipe ,
- \* Defect measured ,
- \* Return leg of cooling water system where repair required ,
- \* Completed repair ,

Application was carried out in accordance with Belzona Know-How System Leaflets VPF-2 and VPF-11. A doubler plate was bonded using Belzona 1111 and was then overcoated with Belzona 1341.
