BELZONA REPAIRS CORRODED TANKS

Application: TCC-Tanks and Chemical Containment Areas

Customer Location: Aggregate Manufacturer, Chelmsford

Storage tanks for molten bitumen

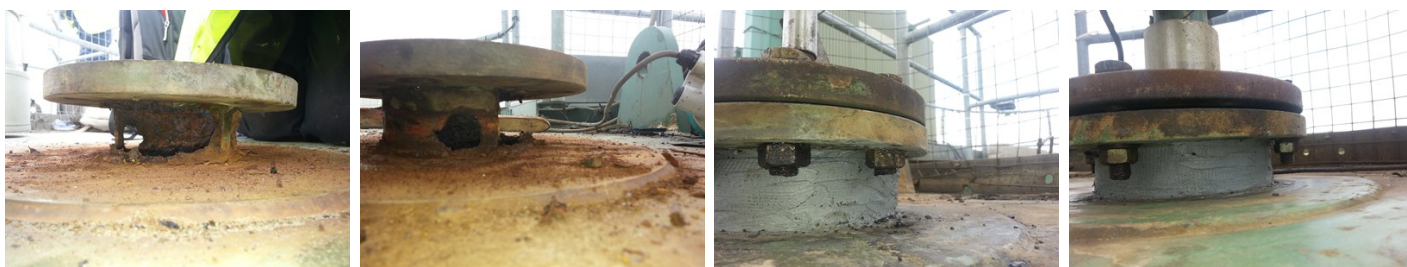
Photograph Descriptions

The tanks have a sensor on top for flow and level readings. They sit on an upstand with a bolted flange. The upstands had been eaten away by the corrosive fumes from the hot bitumen. They were holed through and the gases from the tanks were venting to the atmosphere.

* 1 & 2. Views showing the degree of corrosion present 3 & 4. Completed applications ,

The repairs were carried out in accordance with Belzona System Leaflet TCC-1. After preparing the corroded substrate, bridging tape was applied to span the holes so that product did not fall into the tanks. Three 4mm steel plates were bonded around each upstand before overwrapping with further Belzona incorporating Reinforcement tape.
