BELZONA REPAIRS DAMAGED WASTEWATER PUMP

ID: 5169

Industry: Water / Wastewater
Application: CEP-Centrifugal Pumps
Substrate: Cast Iron
Products: * Belzona 1311 (Ceramic R-Metal) ,
* Belzona 1321 (Ceramic S-Metal) ,

Customer Location: Water Authority, N. Ireland
Application Date: May 2014

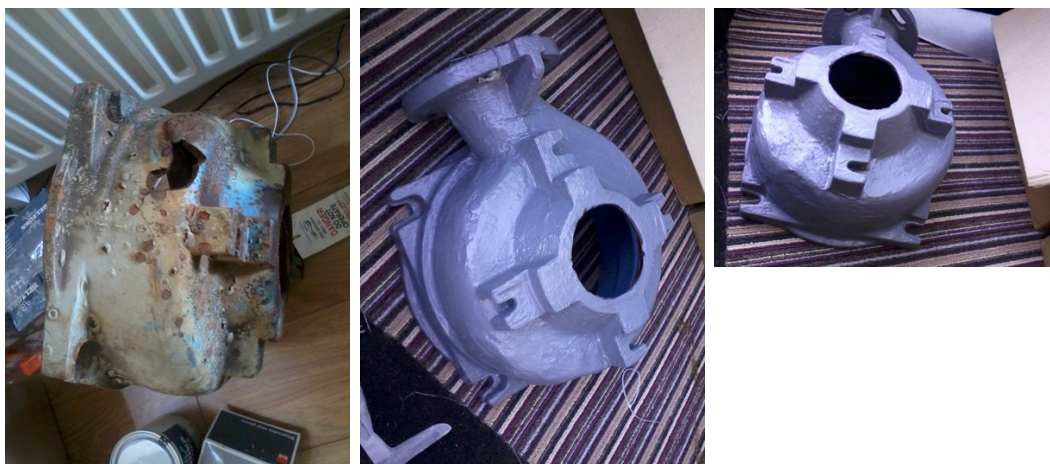
Photograph Descriptions

Erosion from solid material in process fluid had destroyed impellor and holed casing of a wastewater pump.

- * Holed pump casing ,
- * &3. Pump casing rebuilt with Belzona ,

Application was carried out in accordance with Belzona System Leaflets CEP-3 and CEP-6.

The customer had previously used welding to repair the damage but sought a longer lasting, durable repair that did not involve hot work. While the Belzona solution avoided the need to use hot work, it also ensured the equipment could be placed back into service in just 2 days.
