BELZONA SEALS TRANSFORMER MAIN FLANGE

ID: 5171

Industry: Power

Customer Location: Power Distribution Company, South Wales

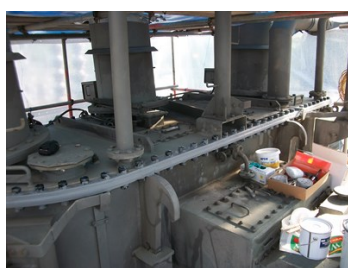
The main flange was discharging high volumes of oil through the failing gasket system. In addition, the top and bottom bolt heads were also leaking. Continual tightening of the bolts over the years was no longer proving effective on the aged transformer. The Client sought a comprehensive, long term solution to seal the main flange and bolt heads.

- * Transformer location ,
- * Preparation & cap fitting ,
- * Cap removal ,
- * Coating with Belzona 5831 to complete the application ,

Application was carried out in accordance with Belzona Know-How System Leaflet VPF-11. Due to a strict outage period and to enhance full success, the Client dropped the oil level beneath the flange level and created the correct working habitat and heat source to reduce product cure time. The flange joint was sealed by applying Belzona 1161 & Belzona 9341 (Reinforcement Tape). The bolt heads were fully encapsulated using a disposable former containing Belzona 1161. Once cured the former removed and the prescribed areas coated with Belzona 5831.
