BELZONA SEALS TRANSFORMER MAIN FLANGE

ID: 5171

Customer Location: Power Distribution Company, South Wales

Application: VPF-Valves, Pipes and Fittings

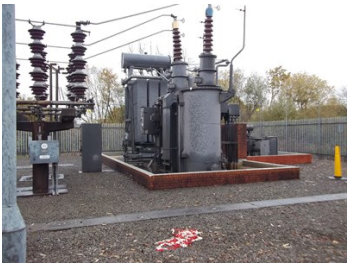
The main flange was discharging high volumes of oil through the failing gasket system. In addition, the top and bottom bolt heads were also leaking. Continual tightening of the bolts over the years was no longer proving effective on the aged transformer. The Client sought a comprehensive, long term solution to seal the main flange and bolt heads.

- * Transformer location ,
- * Preparation & cap fitting ,
- * Cap removal ,
- * Coating with Belzona 5831 to complete the application ,
