# BELZONA SEALS TRANSFORMER MAIN FLANGE

ID: 5171

Customer Location: Power Distribution Company, South Wales

Application: VPF-Valves, Pipes and Fittings

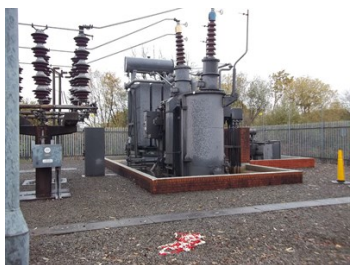
- \* Transformer location ,
- \* Preparation & cap fitting ,
- \* Cap removal ,
- \* Coating with Belzona 5831 to complete the application ,

Transformer within electricity substation
