PVC PIPES AT SWIMMING POOL REPAIRED WITH BELZONA

ID: 5173

Customer Location: Swimming-pool, Dunkerque, France
Application Date: 2012

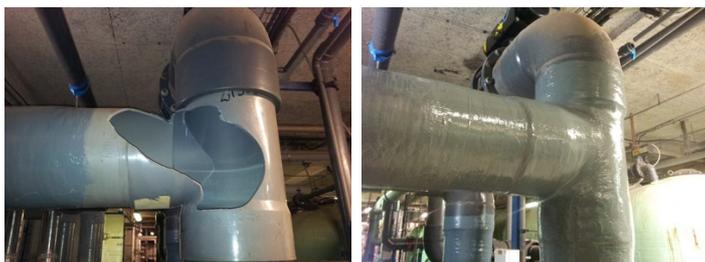
Photograph Descriptions

Emergency stop of the water circulation system during a competition caused the pipe to burst losing large fragments of plastic.

- * View of the damage after the failure of the pipe ,
- * Finished repair on the tee piece ,

20" PVC pipes in water circulation system. System operates at 5 bar pressure and ambient temperature

Application was carried out in accordance with Belzona System Leaflet VPF-11. The substrate was frosted with hand tools before bonding the broken pieces into place and over-wrapping with 3 layers of Belzona 9341 and Belzona 1111. Belzona 1321 was applied as top coat to produce a smooth finish to the repair.

The repair was completed in 5 hours with 2 applicators. The pipe was back into service in 24 hours. The application was inspected in 2013 and is still in place. The city council regularly request similar repairs on other PVC pipes.
