BELZONA REPAIRS SHAFT FOR FRENCH NAVY

ID: 5174

Motor shaft on the frigate "Jean de Vienne"

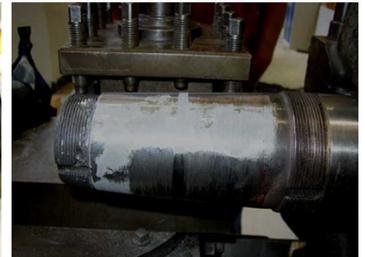
The tapered shaft had serious damage.

- * Frigate "Jean de Vienne" in drydock ,
- * Equipment with the damaged shaft ,
- * Close up of the damage on the shaft ,
- * Shaft after rebuilding with Belzona 1111 and machining ,

Application was carried out in accordance with Belzona Know-How System Leaflet MPT-1. The repair was machined to obtain a smooth finish.

The shaft was recovered back to serviceable condition with minimal downtime ensuring vessel was not delayed in drydock.
