# BELZONA WEATHERPROOFS TWO SUGAR SILOS

ID: 5175

Customer Location: *Sugar factory, Northern France*  
 Application Date: *2014*

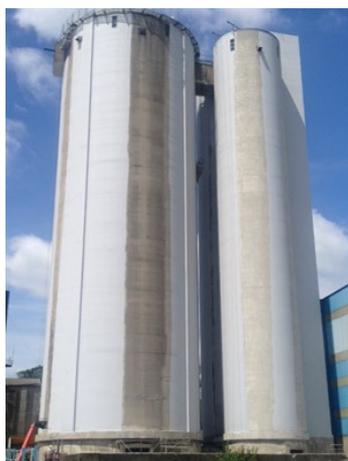
- \* General view of the sugar plant ,
- \* On-going application ,
- \* Finished application ,
- \* 6 years after the application ,

Application was carried out in accordance with Belzona System Leaflet WPA-1. The work was completed by applying the system in vertical stripes of 6 meter width.

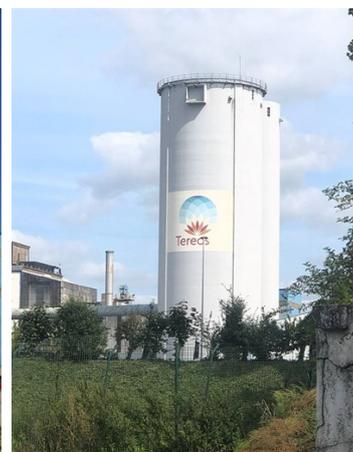
The Belzona 3111 system is proven to provide excellent long term weatherproofing of substrates. The application was carried out in 10 weeks with a team of 7 applicators. The silos have been revisited after 2 years and 6 years later, the application was still in perfect condition.
