BELZONA REBUILDS SPLINE SHAFT

ID: 5182

Industry: *General Industry*
Application: *MPT-Mechanical Power Transmission*

Substrate: *Steel*
Products: ** Belzona 1111 (Super Metal) ,*

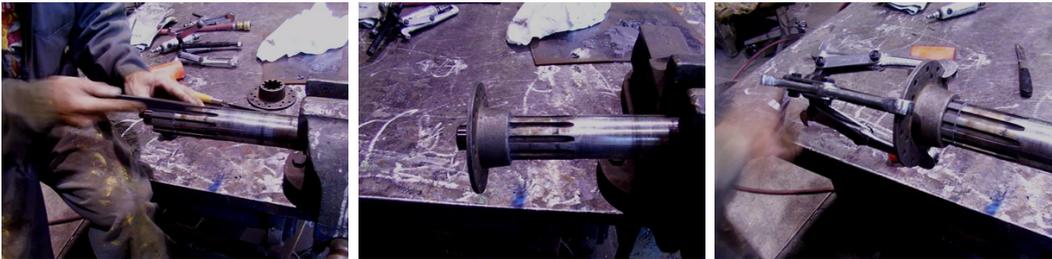
Replacement part not readily available and purchasing the entire assembly would have been very costly.

- * Preparation of the damaged areas in progress ,
- * Splines reformed with Belzona 1111 ,
- * Mounting flange in the process of being removed revealing rebuilt splines. ,

Application carried out in accordance with Belzona Know-How System Leaflet MPT-5

The use of Belzona allowed localized repairs to be executed with a minimal amount of downtime.
