BELZONA REPAIRS CABLE REINFORCED CONVEYOR BELT

ID: 5184

Industry: *General Industry*
Application: *SHM-Solids Handling Machinery*

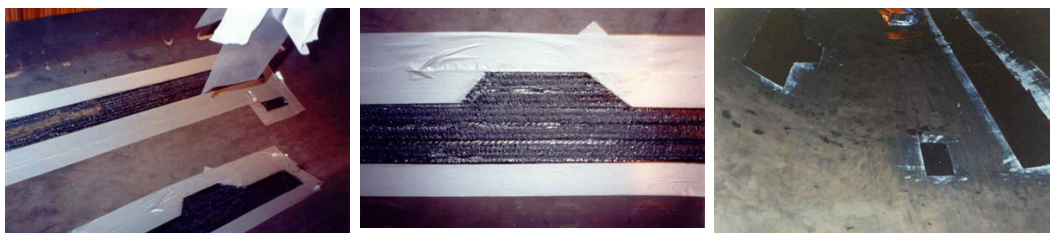
Cable stayed belt would develop cracks over a period of time.

- * View of preparation in progress ,
- * Close-up of one of the repair areas ,
- * Completed application. ,

Cracked cable stayed belt

Application carried out in accordance with Belzona Know-How System Leaflet SHM-1

Because of its rapid set-up time, coupled with its quick development of mechanical strength, Belzona 2311 allowed repairs to be made to the belt during unscheduled or short shut-downs.
