BELZONA SHM-12 POSITIVE GRIP SYSTEMS USED TO RE-LAG DRIVE PULLEY

ID: 5188

Application: *SHM-Solids Handling Machinery*

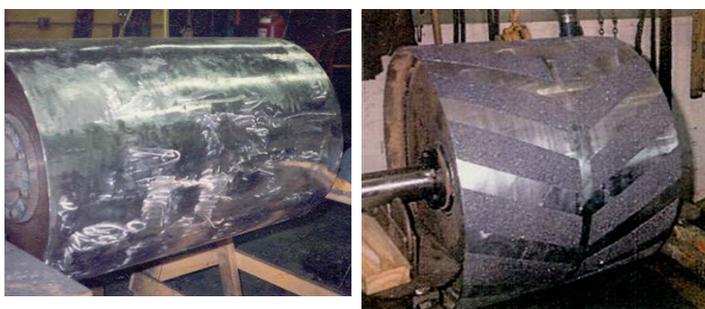
The original rubber lagging was no longer effective and customer opted for Belzona because it could be done in the maintenance shop over the weekend.

* The original lagging has been removed and the steel surface ground to provide a rough profile onto which the Belzona product is applied ,

* Completed application. In this instance a chevron type pattern was employed to ensure that rain water (Outside application) would be swept to the outer circumferences of the roll. ,

Application carried out in accordance with Belzona Know-How System Leaflet SHM-12

The Belzona product is applied directly to the steel roll. It also provides a far higher degree of positive traction increasing belt life by reducing slippage.
