# BELZONA REPAIRS RUBBER LINED SLURRY PUMP

ID: 5189

Rubber lining on a slurry pump

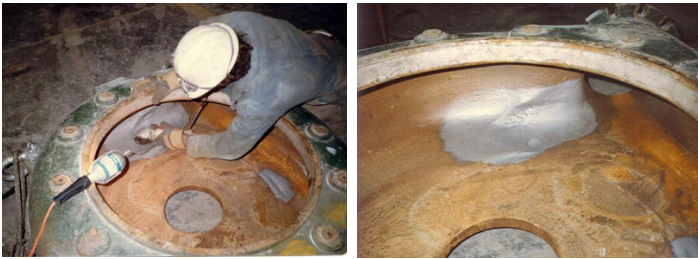
*A hole had worn into the rubber lining in a number of areas from the coal slurry and had started to erode the metal casing.*

- \* Preparation of the damaged areas in progress ,
- \* Preparation completed ,
- \* Rubber liner rebuilt ,

Application carried out in accordance with Belzona Know-How System Leaflet SHM-11

The use of Belzona allowed localized repairs to be executed with a minimal amount of downtime.
