BELZONA REPAIRS RUBBER LINED SLURRY PUMP

ID: 5189

Application: SHM-Solids Handling Machinery

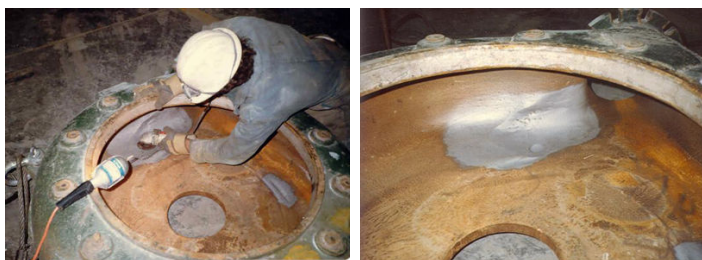
Photograph Descriptions

A hole had worn into the rubber lining in a number of areas from the coal slurry and had started to erode the metal casing.

- * Preparation of the damaged areas in progress ,
- * Preparation completed ,
- * Rubber liner rebuilt ,

Application carried out in accordance with Belzona Know-How System Leaflet SHM-11

The use of Belzona allowed localized repairs to be executed with a minimal amount of downtime.
