BELZONA ELASTOMERS REPAIR CUT IN TIRE

ID: 5192

Industry: *Mining & Quarrying*
Application: *SHM-Solids Handling Machinery*

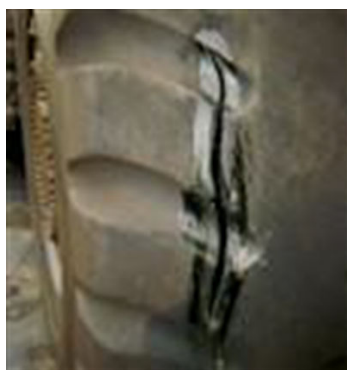
Tire on earthmoving equipment had been badly damaged.

- * View of equipment and the extent of the damaged area ,
- * Surface around the damaged area prepared and coated with Belzona 2911 ,
- * Damaged area sealed and rebuilt with Belzona 2211 ,

Quick repairs to this issue prevented further damage to the underlying reinforcing plies, allowing the equipment to continue operating until a scheduled downtime. Belzona 2311 cures rapidly, reaching full mechanical strength in about 2 hours.
