BELZONA ELASTOMERS REPAIR CUT IN TIRE

ID: 5192

Industry: *Mining & Quarrying*
Application: *SHM-Solids Handling Machinery*

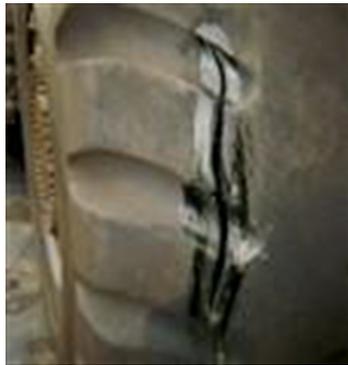
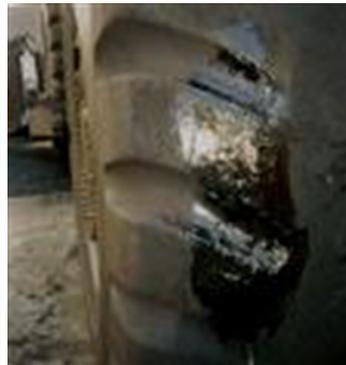
Tire on earthmoving equipment had been badly damaged.

- * View of equipment and the extent of the damaged area ,
- * Surface around the damaged area prepared and coated with Belzona 2911 ,
- * Damaged area sealed and rebuilt with Belzona 2211 ,

Damaged tire

The application was carried out in accordance with Belzona Know-How System Leaflet SHM-1.

Quick repairs to this issue prevented further damage to the underlying reinforcing plies, allowing the equipment to continue operating until a scheduled downtime. Belzona 2311 cures rapidly, reaching full mechanical strength in about 2 hours.
