BELZONA REBUILDS WORN CAT D9 SPLINESHAFT ASSEMBLY

ID: 5194

Industry: *Mining & Quarrying*
Application: *MPT-Mechanical Power Transmission*

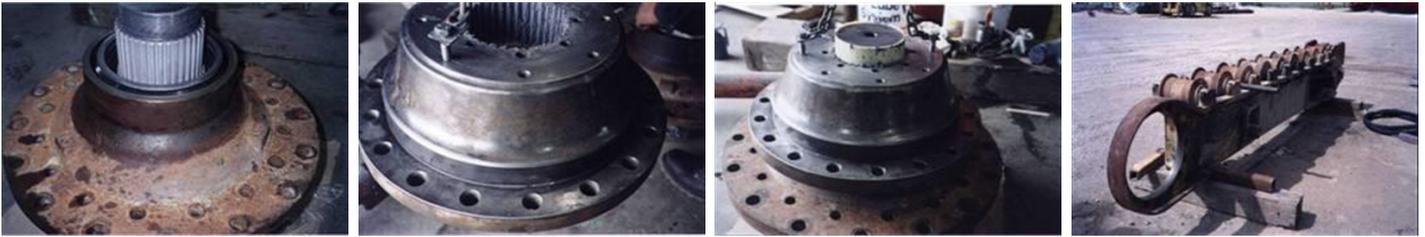
Photograph Descriptions

The main drive spline on D-9 cat had worn loose over many years of service.

- * View of worn spline shaft assembly ,
- * Belzona 1111 Super Metal applied to worn splines ,
- * Components reassembled ,
- * The main framework that the Spline assembly is being bolted to ,

Application carried out in accordance with a modified version of Belzona Know-How System Leaflet MPT-5
