# BELZONA REPAIRS AND SEALS CRACKED TRANSMISSION CASING

ID: 5195

*Repairing cracked and leaking transmission housing*

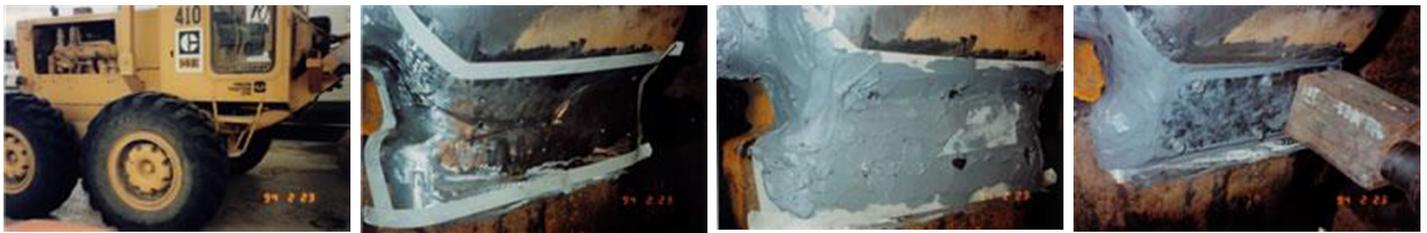
- \* View of equipment ,
- \* Crack & " out and the surface area around it roughened ,
- \* Belzona 1111 applied to the area around the repair ,
- \* A reinforcement plate bolted over the uncured Belzona material to provide additional mechanical strength to the area. ,

Application carried out in accordance with a modified version of Belzona Know-How System Leaflet MPT-1

A Belzona repair allowed casing to be repaired with the minimum amount of disassembly and downtime.
