BELZONA EXTENDS THE LIFE OF DAMAGED TIRE

ID: 5196

Application: *SHM-Solids Handling Machinery*

Repair of the side wall of a tire

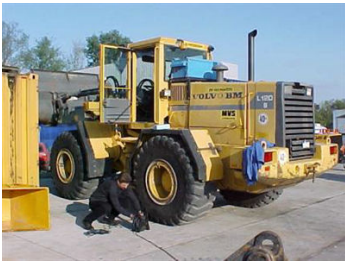
The side wall of a tire, close to the rim, had been cut by a stray piece of metal

- * Vehicle with damaged tire ,
- * Initial preparation underway with the removal of any loose material ,
- * The surface around the damaged area is prepared with a special roughing tool ,
- * Completed application. ,

Application carried out in accordance with a modified version of Belzona Know-How System Leaflet SHM-1. Surface around damaged area cleaned of loose road debris and roughen with a steel wire brush. Belzona 2911 (Elastomer QD Conditioner) was applied prior to Belzona 2211 to ensure proper adhesion.
