BELZONA 2311 (SR ELASTOMER) USED FOR EMERGENCY REPAIRS

ID: 5197

Industry: *Mining & Quarrying*
Application: *SHM-Solids Handling Machinery*

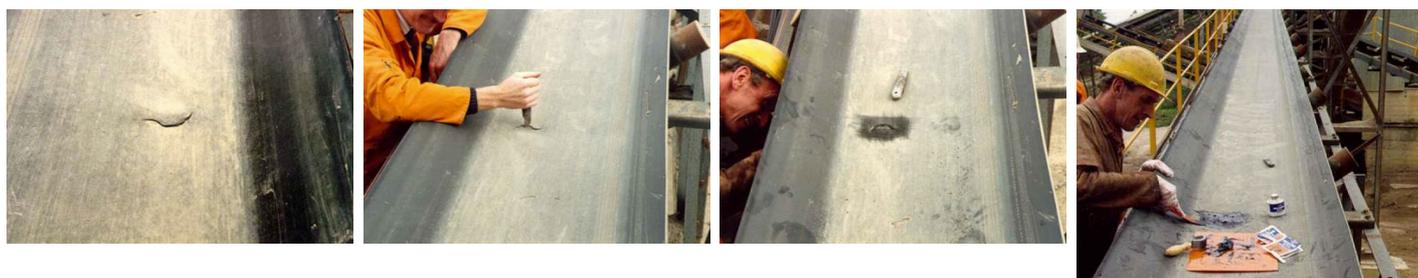
Photograph Descriptions

A small cut had developed in a section of the belt

- * View of the cut in the belt ,
- * Initial preparation underway ,
- * The loose piece of belting has been cut away and area around it roughed up with a special roughing tool ,
- * Repair in progress ,

Belt repair in gravel pit

Application carried out in accordance with a modified version of Belzona Know-How System Leaflet SHM-1

The use of Belzona 2311 allowed the yard to repair the damage before it became more serious. The quick setting properties of the repair material also allowed the repair to be completed during a lunch break ensuring no downtime.
