BELZONA 1811 CERAMIC CARBIDE EXTENDS LIFE OF PUMP CASING

Industry: *Mining & Quarrying*
Application: *CEP-Centrifugal Pumps*
Substrate: *Stainless steel*
Products: ** Belzona 1811 (Ceramic Carbide) ,*

Customer Location: *BC, Canada*
Application Date: *June 2000*

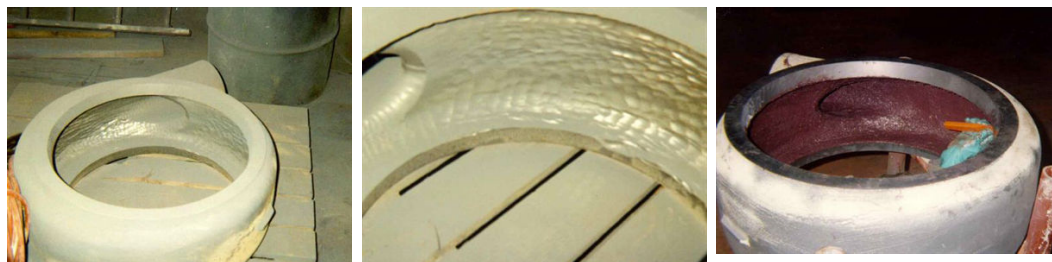
Photograph Descriptions

Pumping drainage water from a gravel pit has a high percentage of entrained solids causing major erosion damage to pumps

- * View of Pump ,
- * Close-up of pump showing extent of erosion ,
- * The internal surfaces of the pump casing are protected with Belzona 1811 ,

Erosion on gravel slurry pump

Application carried out in accordance with a modified version of Belzona Know-How System Leaflet CEP-1

Coating the internal surfaces with a sacrificial coating such as Belzona 1811 ensures that the pump casing can be recycled many times over
