BELZONA 2200 SERIES ELASTOMERS REPAIR SPLIT CONVEYOR BELT

ID: 5199

Industry: *Mining & Quarrying*
Application: *SHM-Solids Handling Machinery*

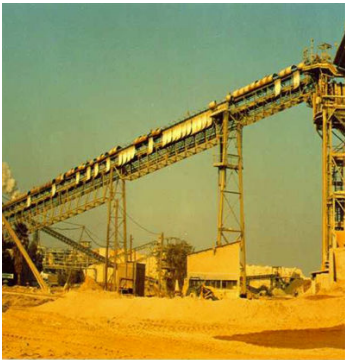
- * Conveyor system in need of repair ,
- * The damaged portions of the belt were held together using mechanical fasteners ,
- * Close-up of fasteners and the prepared belt surfaces conditioned with Belzona 2911 ,
- * The completed repair ,
