BELZONA 2200 SERIES ELASTOMERS REPAIR SPLIT CONVEYOR BELT

ID: 5199

Industry: *Mining & Quarrying*
Application: *SHM-Solids Handling Machinery*

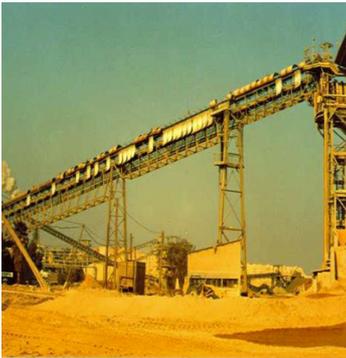
A mechanical breakdown had caused the belt to be split over a length of approximately 100 feet.

- * Conveyor system in need of repair ,
- * The damaged portions of the belt were held together using mechanical fasteners ,
- * Close-up of fasteners and the prepared belt surfaces conditioned with Belzona 2911 ,
- * The completed repair ,
