BELZONA REBUILDS ERODED METAL AND DAMAGED LINER

ID: 5201

Lining repair of a sand and gravel hopper

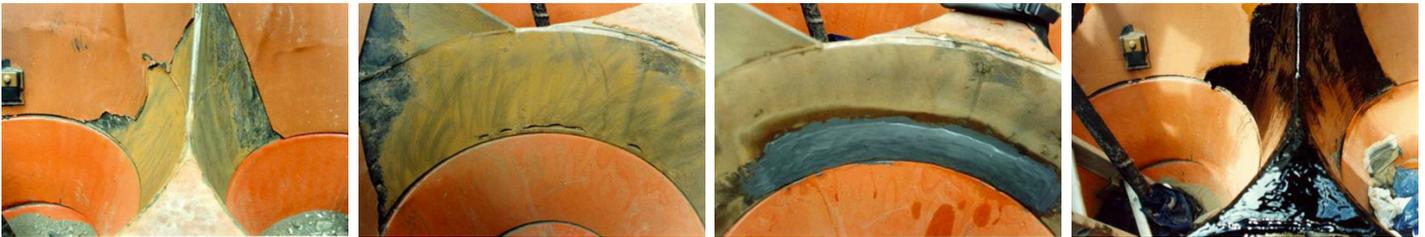
Photograph Descriptions

The abrasion resistant lining of the hoppers had been damaged allowing corrosion to develop underneath it

- * Sand and Gravel Hopper ,
- * View of the damaged liner ,
- * Damaged liner stripped from the affected areas ,
- * After preparing the metal surfaces the eroded area was rebuilt with Belzona 1311 ,

Application carried out in accordance with Belzona Know-How System Leaflet SHM-1
