# BELZONA 1000 SERIES PRODUCTS RE-SEAT WEAR PLATES

ID: 5202

## Problem

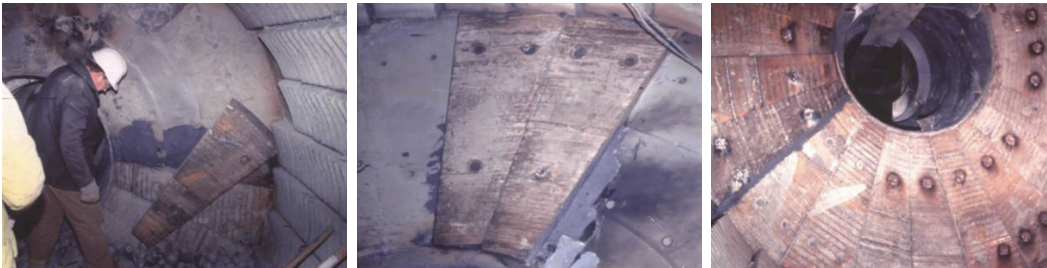
## Photograph Descriptions

*The base plate of the Bradley Pulverizer had worn unevenly making it difficult to effectively reinstall new wear plates*

- \* Belzona 1121 has been applied to all the worn areas, while a release agent has been applied to the underside of the new wear plates to ensure that they are easily removed when required ,
- \* Installation in progress ,
- \* Completed application. ,
