# BELZONA EXTENDS LIFE OF JET VALVE

Application: CEP-Centrifugal Pumps

Worn jet valves

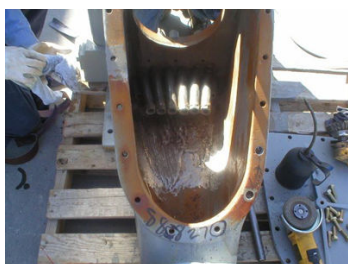
*These jet valves would generally last about 5-6 months before they would wear through from the air / sand / water mixture pumped through them.*

- \* View of the volute area ,
- \* Showing preparation in progress of the eroded area ,
- \* Application of the Belzona material in progress ,
- \* Application of the Belzona 1812 in progress ,
