# Centrifuge Asset Recovery

ID: 5206

Centrifuge for process with high levels of brine present in the service causing internal, and external corrosion.

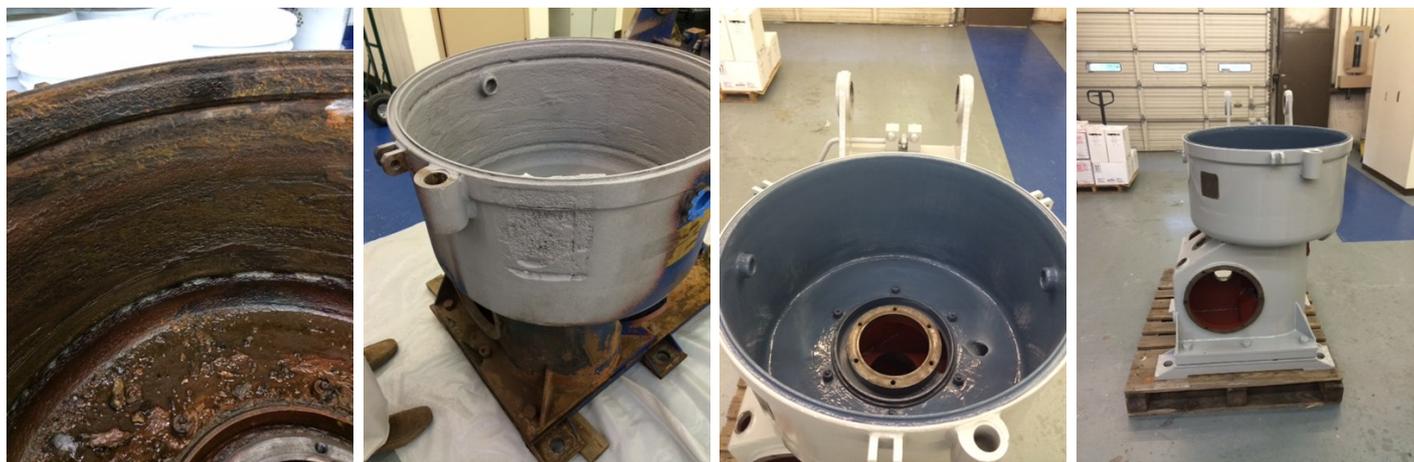
Corrosion of the internals lead to heavy pitting, and wall thickness of the carbon steel. It also led to the complete disintegration of the external water box and it's mount. The customer only had 4-5 days to make repairs or replace it with a new one. Lead time for a new centrifuge was weeks out, so a Belzona Turnkey application was their best option. The exterior was also protected with Belzona 5811, and 5111.

- \* View of the interior bowl of the corroded centrifuge shortly after being taken out of service ,
- \* Blasted internal and external substrate ,
- \* Internal bowl coated with Belzona 1321 ,
- \* External repaired with Belzona 1111 and Belzona 9341, and coated with Belzona 5811 and Belzona 5111 ,

The application was carried out in accordance with Belzona Know-How System Leaflet CEP-3, and CEP-4. The interior pitting was repaired with Belzona 1111, and subsequently coated with Belzona 1321. The exterior was repaired in one area with Belzona 1111 and Belzona 9341, then coated with Belzona 5811 and Belzona 5111.
