# BELZONA PROTECTS STRUCTURAL STEEL OF A PAPER MACHINE

ID: 5208

Customer Location: *New England, USA*  
Application Date: *Summer 2014*

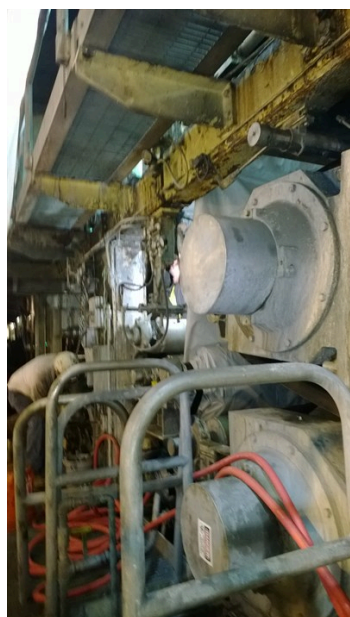
*The paper machine structural steel was severely corroded and in need of corrosion protection.*

- \* Section of paper machine press ,
- \* Paper machine name plate with corrosion ,
- \* Close-up view of corrosion ,
- \* Completed application ,

Hand tools, such as needle guns and grinders, were used for surface preparation before smoothing with Belzona 1121 and overcoating with Belzona 5811. The application was carried out with a modified version of Belzona Know-How System Leaflet TCC-5.
