BELZONA REPAIRS AND PROTECTS THE LINING OF FLOTATION CELLS

Customer Location: Mining Plant, Brazil

Flotation cell of 6.5 meters in diameter and bottom area of 33.2 m2

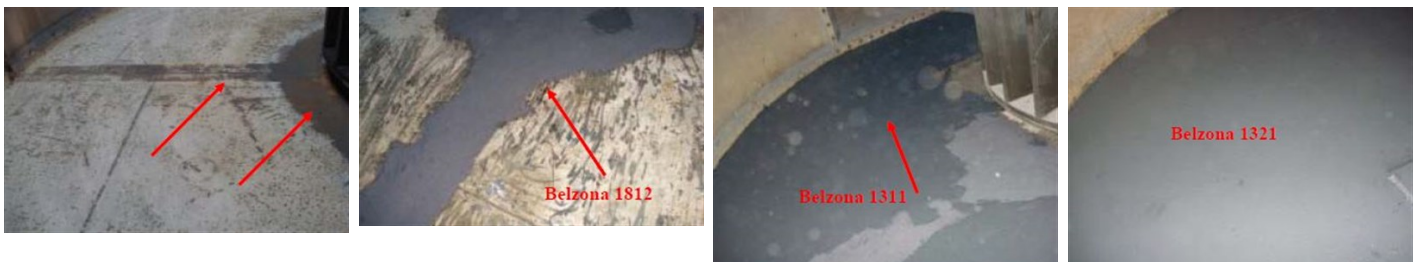
Photograph Descriptions

Copper pulp leak through the bottom of the flotation cell due to corrosion and localized worn areas with severe abrasion.

- * Bottom of the flotation cell showing corrosion areas ,
- * Holes repaired with Belzona 1812 ,
- * Holes repaired with Belzona 1311 ,
- * Bottom of the flotation cell coated with Belzona 1321 ,

This application was carried out in accordance with Belzona Know-How System Leaflet TCC-3. First, the bottom of the flotation cell was washed and the ore residue removed, the surface was prepared with an electric grinder, and the area to be coated was cleaned. After that, the areas with severe wear were repaired with a layer of Belzona 1812, approximately 3 mm thick, to store the thickness of the surface. Then, Belzona 1311 was applied on the remaining worn areas of the bottom of the flotation cell. Finally, the entire bottom area of the flotation cell was coated with Belzona 1321.
