# BELZONA REPAIRS AND PROTECTS THE LINING OF FLOTATION CELLS

ID: 5210

Customer Location: *Mining Plant, Brazil*

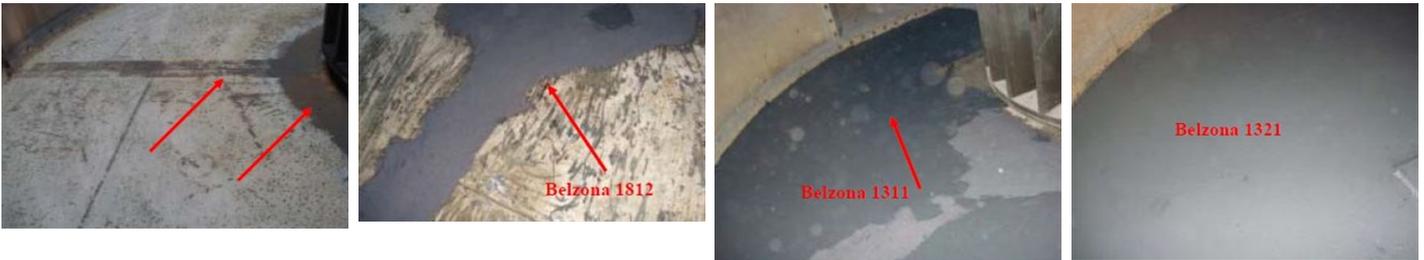
## Photograph Descriptions

*Copper pulp leak through the bottom of the flotation cell due to corrosion and localized worn areas with severe abrasion.*

- \* Bottom of the flotation cell showing corrosion areas ,
- \* Holes repaired with Belzona 1812 ,
- \* Holes repaired with Belzona 1311 ,
- \* Bottom of the flotation cell coated with Belzona 1321 ,

This application was carried out in accordance with Belzona Know-How System Leaflet TCC-3. First, the bottom of the flotation cell was washed and the ore residue removed, the surface was prepared with an electric grinder, and the area to be coated was cleaned. After that, the areas with severe wear were repaired with a layer of Belzona 1812, approximately 3 mm thick, to store the thickness of the surface. Then, Belzona 1311 was applied on the remaining worn areas of the bottom of the flotation cell. Finally, the entire bottom area of the flotation cell was coated with Belzona 1321.
