BELZONA REDUCES DOWNTIME WITH SHAFT REPAIR

Industry: General Industry
Application: FBC-Fans, Blowers and Compressors

Customer Location: Toronto, ON, Canada
Application Date: July 2014

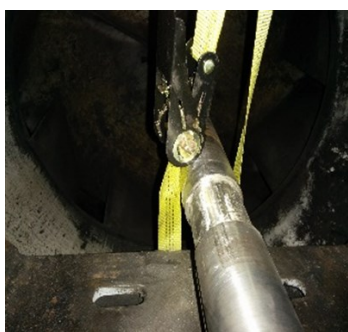
Bearing failure caused severe scoring to shaft.

- * Prior to application ,
- * Preparation in process ,
- * Completed application ,
- * Completed application in service ,

The application was carried out in accordance with Belzona Know-How System Leaflet FBC-13 for repairing shafts by forming techniques. The surface was prepared by mechanical grinding and cleaning with Belzona 9111 to remove all residue. The former's interior was prepared with Belzona 9411. Belzona 1111 was applied to the shaft and former, and the former was installed on the

shaft. After curing, the former was removed and the shaft was checked for fit tolerance.
