EXPANSION JOINTS REPAIRED WITH BELZONA

ID: 5217

Industry: Buildings & Structures
Application: FPA-Floor Problem Areas
Substrate: Concrete
Products: * Belzona 2131 (D & A Fluid Elastomer) ,
* Belzona 2911 (Elastomer QD Conditioner) ,

Customer Location: London, ON, Canada
Application Date: May 2014

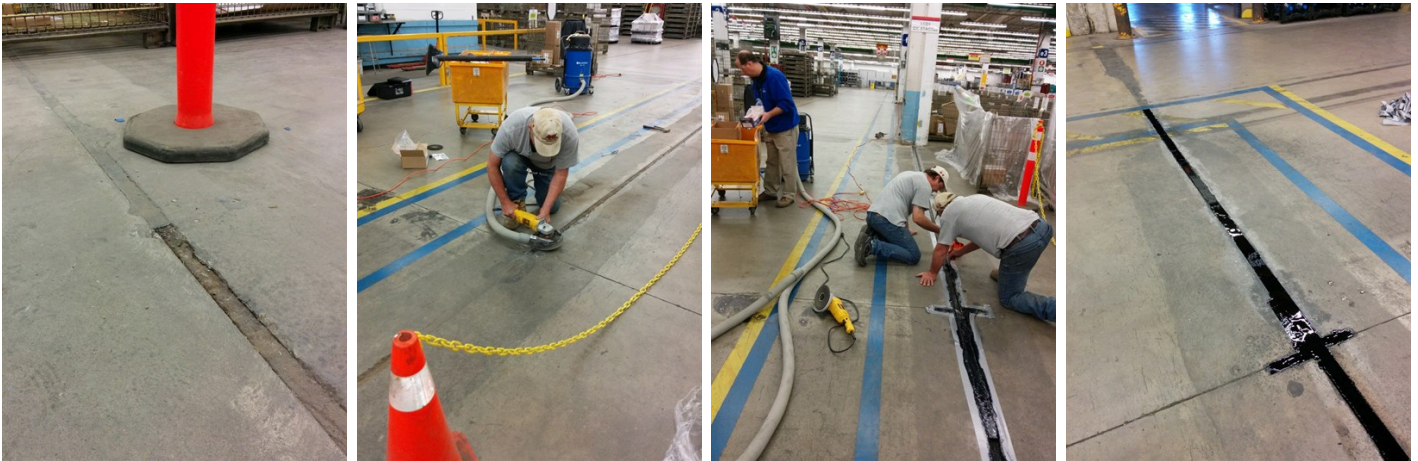
Photograph Descriptions

The previous joint had failed, and the area of the floor was closed off to fork lifts and handling equipment.

- * Prior to application ,
- * Preparation in progress ,
- * Application in progress ,
- * Completed application ,

The application was carried out in accordance with Belzona Know-How System Leaflet FPA-6 for replacing expansion joint sealants. The concrete was prepared by removing the existing expansion joint by hand and with a hand grinder, together with a vacuum to drastically reduce the dust to clean the concrete. The application area was taped and Belzona 2911 was applied over the entire joint area. Then Belzona 2131 was poured into the joint. The tape was removed after application.
