BELZONA SAVES HEAT EXCHANGER FROM COSTLY REPLACEMENT

Application: HEX-Heat Exchangers

Heat exchanger covers.

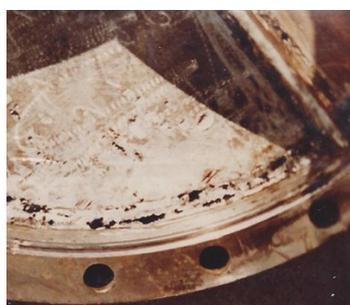
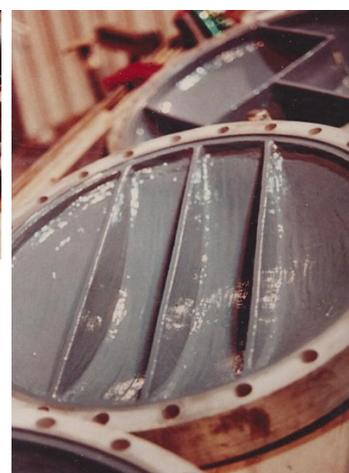
Photograph Descriptions

All ten heat exchangers had been replaced just one year ago. The covers were stainless steel but were welded with a carbon steel rod, setting up electrolysis. Replacements would take more than 3 months to build and a cost of downtime at \$70,000.00 per day. With Belzona, all ten were rebuilt in just seven days. They were opened one year later and the heat exchangers were found to be in perfect condition.

- * End cover showing electrolysis ,
- * Close up of damage ,
- * & 4. Completed application on end cover ,

The application was carried out in accordance with Belzona Know-How System Leaflet HEX-2.

The alternative was ten new heat exchangers costing over \$500,000.00 plus several millions of dollars in downtime. Instead, all of the ten heat exchangers were rebuilt in seven days with Belzona, costing only \$15,000.00.
