BELZONA REPAIRS TUBE SHEETS OF A HEAT EXCHANGER

ID: 5220

Application: HEX-Heat Exchangers

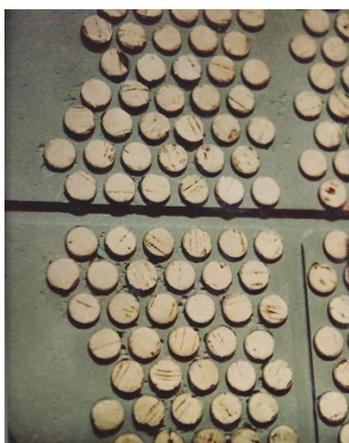
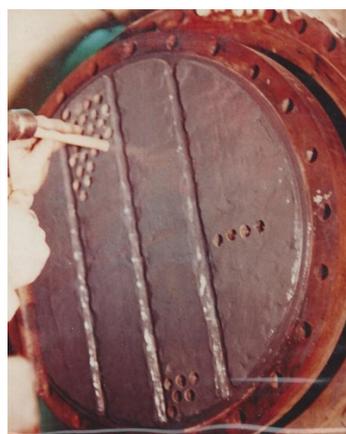
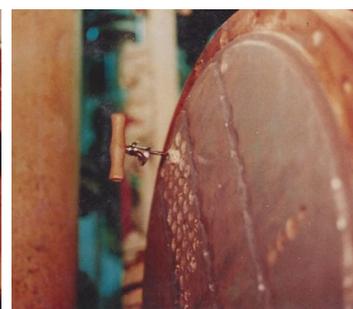
Photograph Descriptions

One year old tube sheets were already leaking around the tubes. Electrolysis has eaten away much of the tube sheet and plate.

- * Tube sheet with corks inserted ,
- * Applying Belzona 1311, then two coats of Belzona 1321 ,
- * Breaking corks loose with wood dowel ,
- * Pulling corks with a cork screw ,

The application was carried out in accordance with Belzona Know-How System Leaflet HEX-1.

The alternative was ten new heat exchangers costing over \$500,000.00 plus several millions of dollars in downtime. With Belzona,

all ten of the heat exchangers were rebuilt in seven days using only \$15,000.00, saving time and money.
