BELZONA REPAIRS TUBE SHEETS OF A HEAT EXCHANGER

ID: 5220

Application: HEX-Heat Exchangers

Heat exchanger tube sheets.

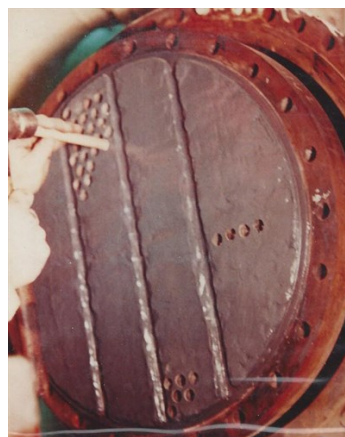
Photograph Descriptions

One year old tube sheets were already leaking around the tubes. Electrolysis has eaten away much of the tube sheet and plate.

- * Tube sheet with corks inserted ,
- * Applying Belzona 1311, then two coats of Belzona 1321 ,
- * Breaking corks loose with wood dowel ,
- * Pulling corks with a cork screw ,

The application was carried out in accordance with Belzona Know-How System Leaflet HEX-1.

all ten of the heat exchangers were rebuilt in seven days using only \$15,000.00, saving time and money.
