# BELZONA SAVES CENTRIFUGAL PUMP FROM REPLACEMENT

ID: 5221

Industry: Food & Drink  
Application: CEP-Centrifugal Pumps  
Substrate: Cast Iron  
Products: \* Belzona 1341 (Supermetalgilde) ,

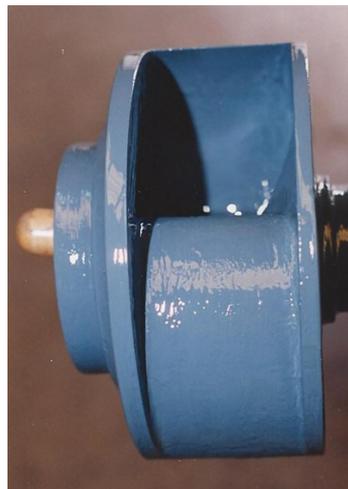
Erosion/Corrosion was eating away this water pump at a fruit processing company, causing it to pump less water than was required. It was then pulled from the scrap pile.

- \* Damaged Cornell pump ,
- \* Coating of impeller ,
- \* Coating of pump casing ,

The application was carried out in accordance with Belzona Know-How System Leaflet CEP-10. The centrifugal pump was rebuilt to improve efficiency.

The customer was ready to replace the pump because it just wasn't pumping enough water. Belzona 1341 improved the volume, enough to satisfy their needs.
