# BELZONA 3411 SOLVES CORROSION ISSUE FOR A CHEMICAL PLANT

ID: 5222

Application: GSS-Gaskets, Seals and Shims

Customer Location: Chemical Plant, South Louisiana, USA

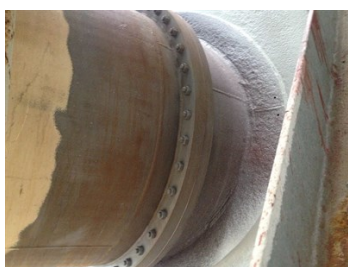
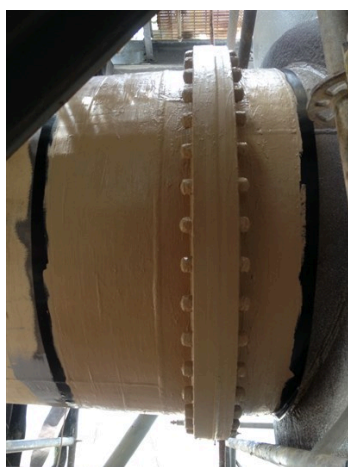
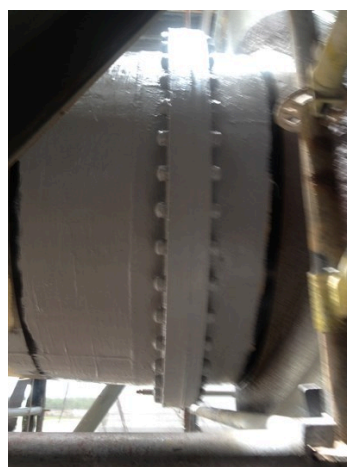
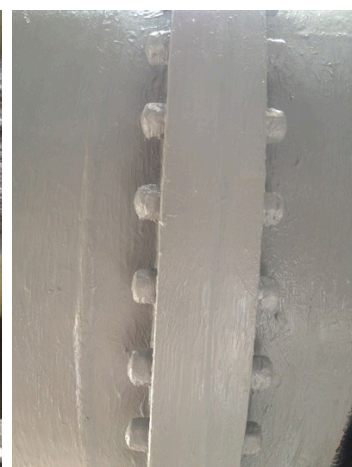
Customer has 52" flange on vessel that needs corrosion protection. Other vessels in unit have hefty fiberglass coverings that are difficult to remove and expensive to apply.

- \* 1. 52" Flange prepared for application, grit blasted ,
- \* 2. First coat of Belzona 3411 ,
- \* 3. Second coat of Belzona 3411 ,
- \* 4. Final sideview of flange ,

The application was carried out in accordance with Belzona Know-How System Leaflet GSS-11.

be opened, can use a box knife instead of a heat gun or grit blast equipment! Customer had seen Belzona 3411 advertised in Distributor Newsletter and thought it was worth trying this application. The unit was inspected 90 days after the install and it looked as good as it did on day 1.
