# BELZONA REPAIRS A TIRE OF A DUMP TRUCK

ID: 5223

Industry: Mining & Quarrying  
Application: SHM-Solids Handling Machinery

Customer Location: Mine, MG, Brazil  
Application Date: May, 2007

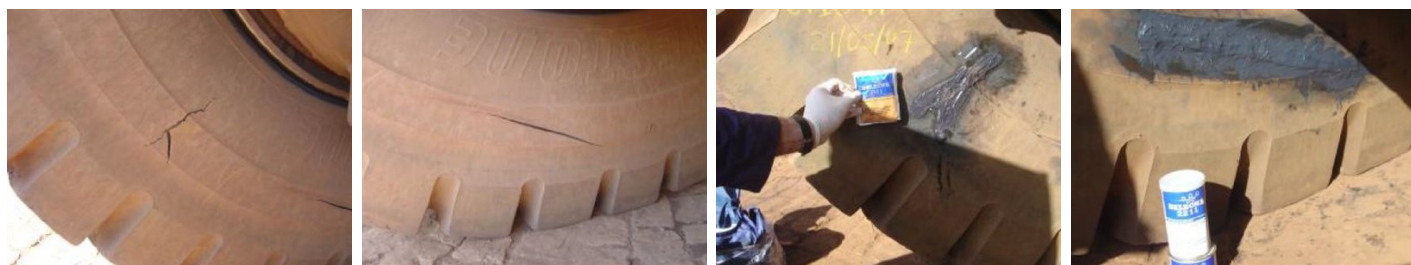
One of the tires of the dump truck had two lateral cuts, which reached the metal mesh and may have been caused by stone impact during movement. It was necessary to repair the affected area in order to prevent the cut from expanding and the tire to become useless before the end of its useful life. Lateral cuts measured 130 mm and 500 mm in length and 40 and 60 mm in depth.

- \* One of the cuts on the side of the tire ,
- \* Another cut on the side of the tire ,
- \* Application of Belzona 2311 ,
- \* Application of Belzona 2211 ,

The application was conducted according to Belzona Know-How System Leaflet SHM-9. The lateral cut was opened and all the loose rubber was removed, reaching the inner liners, without exacerbating the problem. After scarification of the rubber, cleaning of the cut and application of Belzona 2911 conditioner, two repairs were made: the first one with the application of Belzona 2311 and the second one with the application of Belzona 2211.

The Belzona repair remained adhered with excellent performance for more than 60 days (more than 1,500 hours), which was the time period requested by the client.
