# BELZONA PROTECTS AND COATS PUMPS

Industry: Power  
Application: CEP-Centrifugal Pumps  
Substrate: Steel and cast iron  
Products: \* Belzona 1311 (Ceramic R-Metal) ,  
\* Belzona 1341 (Supermetalglide) ,

Customer Location: MO, USA  
Application Date: March 2011

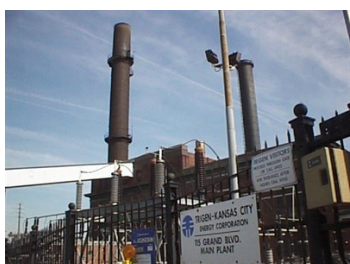
- \* View of the Energy Company ,
- \* Previous application by Belzona ,
- \* Preparing the product for application ,
- \* Completed application ,

All of the equipment receiving the Belzona coating was grit blasted with Black Beauty and then cleaned. Any severe pitting and erosion was addressed by rebuilding with Belzona 1311 and finished with two coats of Belzona 1341, the known pump-efficiency enhancement system. The application was carried out in accordance with Belzona Know-How System Leaflets CEP-3 & CEP-5.

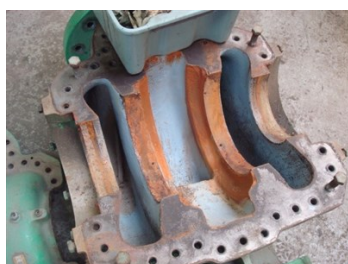
The customer wanted to re-coat the pump although it showed very little sign of wear.
