BELZONA PROTECTS AND COATS PUMPS

ID: 5226

Industry: Power
Application: CEP-Centrifugal Pumps
Substrate: Steel and cast iron
Products: * Belzona 1311 (Ceramic R-Metal) ,
* Belzona 1341 (Supermetalgilde) ,

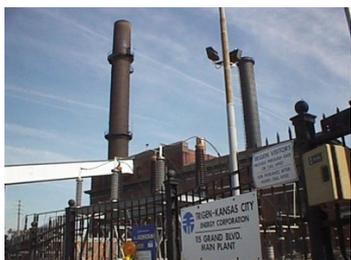
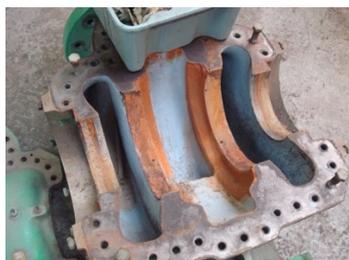
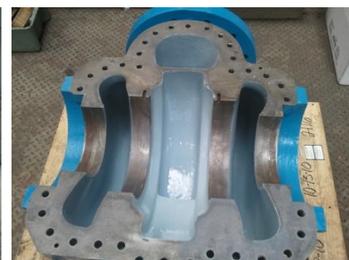
Photograph Descriptions

- * View of the Energy Company ,
- * Previous application by Belzona ,
- * Preparing the product for application ,
- * Completed application ,

All of the equipment receiving the Belzona coating was grit blasted with Black Beauty and then cleaned. Any severe pitting and erosion was addressed by rebuilding with Belzona 1311 and finished with two coats of Belzona 1341, the known pump-efficiency enhancement system. The application was carried out in accordance with Belzona Know-How System Leaflets CEP-3 & CEP-5.
