BELZONA REPAIRS AND COATS PUMP CASE

ID: 5228

Application: CEP-Centrifugal Pumps

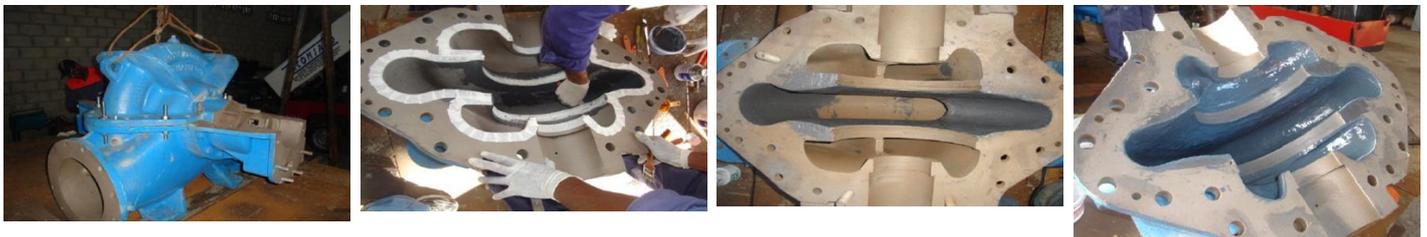
The equipment presented minor wear due to localized corrosion on the casing. It was necessary to restore the worn areas and apply a lining with excellent corrosion and high temperature resistance. The fluid consists of a caustic soda solution with few solids at a temperature of 81° C. Speed rotation: 1789 rpm.

- * Equipment assembled before the repair ,
- * Case refurbishment with Belzona 1111 ,
- * Case refurbishment concluded with Belzona 1111 ,
- * Service concluded, case lined with Belzona 1391 ,

The repair and coating were carried out in accordance with Belzona Know-How System Leaflets CEP -3 & CEP-5. The surface was prepared by dry abrasive blasting at near white metal. After the surface preparation, Belzona 1311 was applied to rebuild the casing and Belzona 1111 was applied on the ring seating. After that, a single coat of Belzona 1391 was applied with a 600 to 750 µm thickness on the entire internal surface of the casing.
