BELZONA SAVES PUMP FROM REPLACEMENT

ID: 5231

Industry: Fluid Flow
Application: CEP-Centrifugal Pumps
Substrate: Cast iron and Steel
Products: * Belzona 1341 (Supermetalgilde) ,
* Belzona 1121 (Super XL-Metal) ,

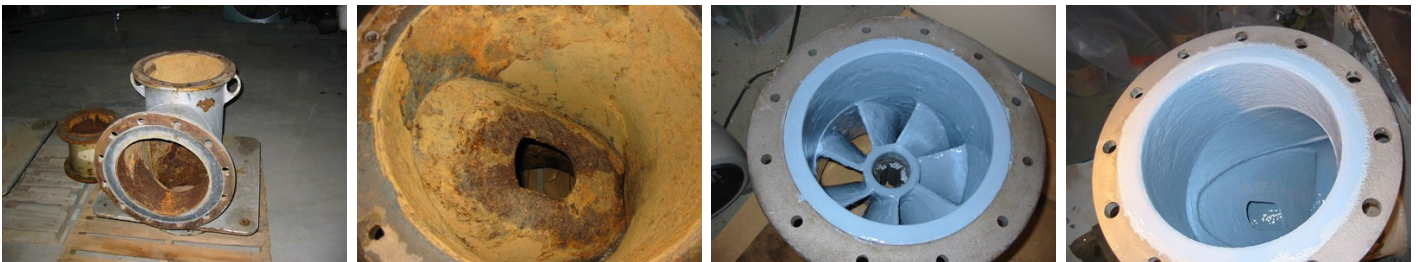
Photograph Descriptions

The pumps from one of this well-known amusement park's water rides had badly corroded with severe loss of metal. The corrosion was so thick that the pumps required grit blasting three times to achieve a proper profile. A solution was sorely needed.

- * Overview of the pump ,
- * Sever corrosion damage to the pump ,
- * Completed application ,
- * Completed application ,

The most severe corrosion areas were repaired with Belzona 1121 followed by two coats of Belzona 1341 to provide a long-lasting, super slick surface. The application was carried out in accordance with Belzona Know-How System Leaflets CEP-1 & CEP-10.
